Manhole Inspection Summary

Manhole # S13AA1028MH

Location Address: **3919 WABASH AVE**

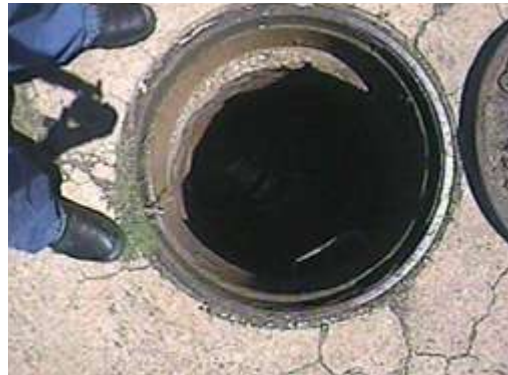
Top View

Frame Offset: **3** (in.) Condition: ☒ Sound ☐ Cracked ☐ Leaks

FRAME OFFSET

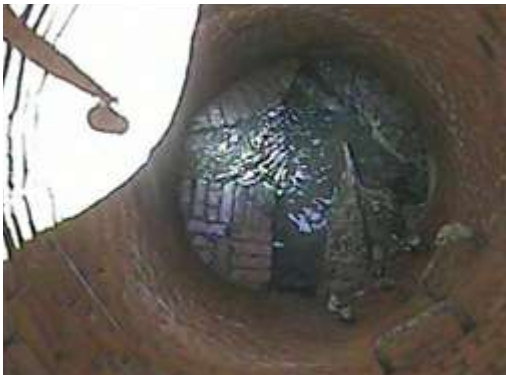
Top View

FRAME OFFSET

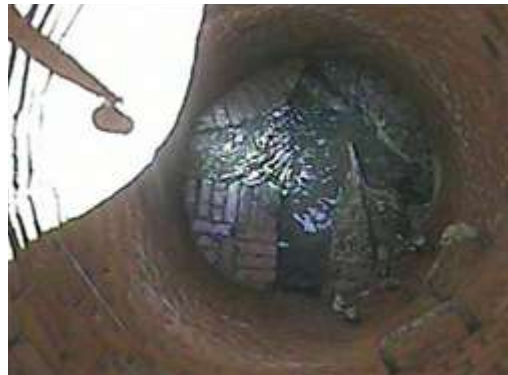
Defect 1

Condition: ☐ Sound ☐ Cracked ☐ Root Intrusion ☐ Deteriorated ☐ Leaks ☒ **Debris**

DEBRIS ON BENCH AND IN CHANNEL

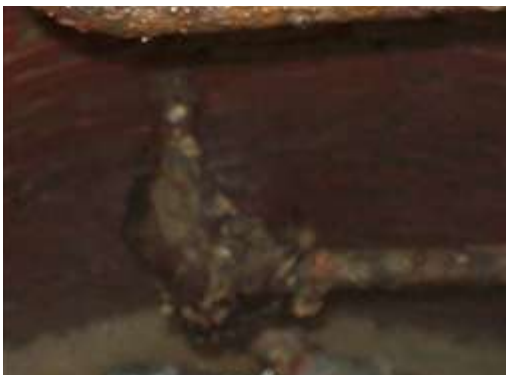
Defect 3

Surcharge ☒ **Evidence Of Surcharge** Depth: **3** (ft.) ☐ Active Surcharge Present

SURCHARGE EVIDENCE

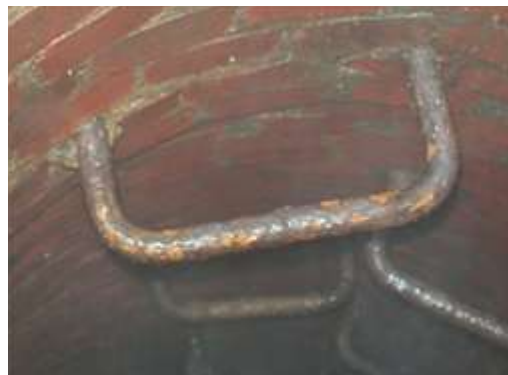
Defect 2

Steps Count: **8** Missing: **0** ☒ **Corroded**

CORRODED STEPS

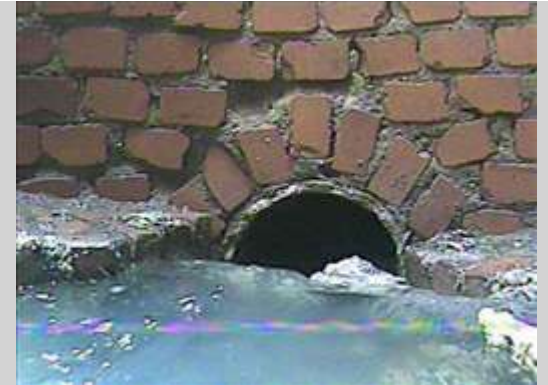
12 O'Clock Outflow

Pipe Height: (in.) Direct
Pipe Material: **Clay** ☐ Pipe Lined
Invert Depth: **12.61** (ft.) Flow Characteristics: **Slow**
Deposits: ☒ None ☐ Mud ☐ Sludge ☐ Debris ☐ Grease
Silt Depth: (in.) Deposits Extent:
Infiltration: **None** Pipe Seal Cond: **Broken**

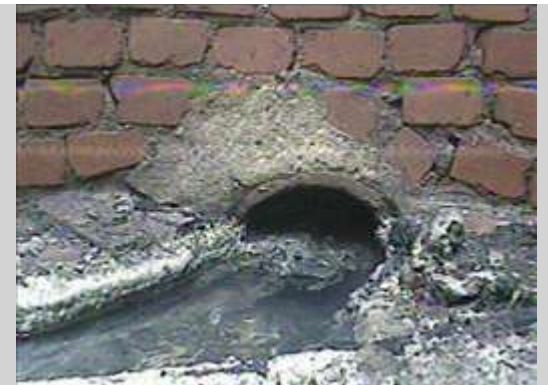
3 O'Clock Inflow

Pipe Height: (in.) Direct
Pipe Material: **Clay** ☐ Pipe Lined
Invert Depth: **12.30** (ft.) Flow Characteristics: **Slow**
Deposits: ☐ None ☐ Mud ☒ Sludge ☒ Debris ☒ Grease
Silt Depth: **5** (in.) Deposits Extent: **Heavy**
Infiltration: **None** Pipe Seal Cond: **Sound**
